INVESTIGATION OF BLADE FAILURES IN A J34, ELEVEN-STAGE  
AXIAL-FLOW COMPRESSOR

By Howard F. Calvert, André J. Meyer, Jr. and C. Robert Morse

Lewis Flight Propulsion Laboratory  
Cleveland, Ohio

Copy  
RM E52116

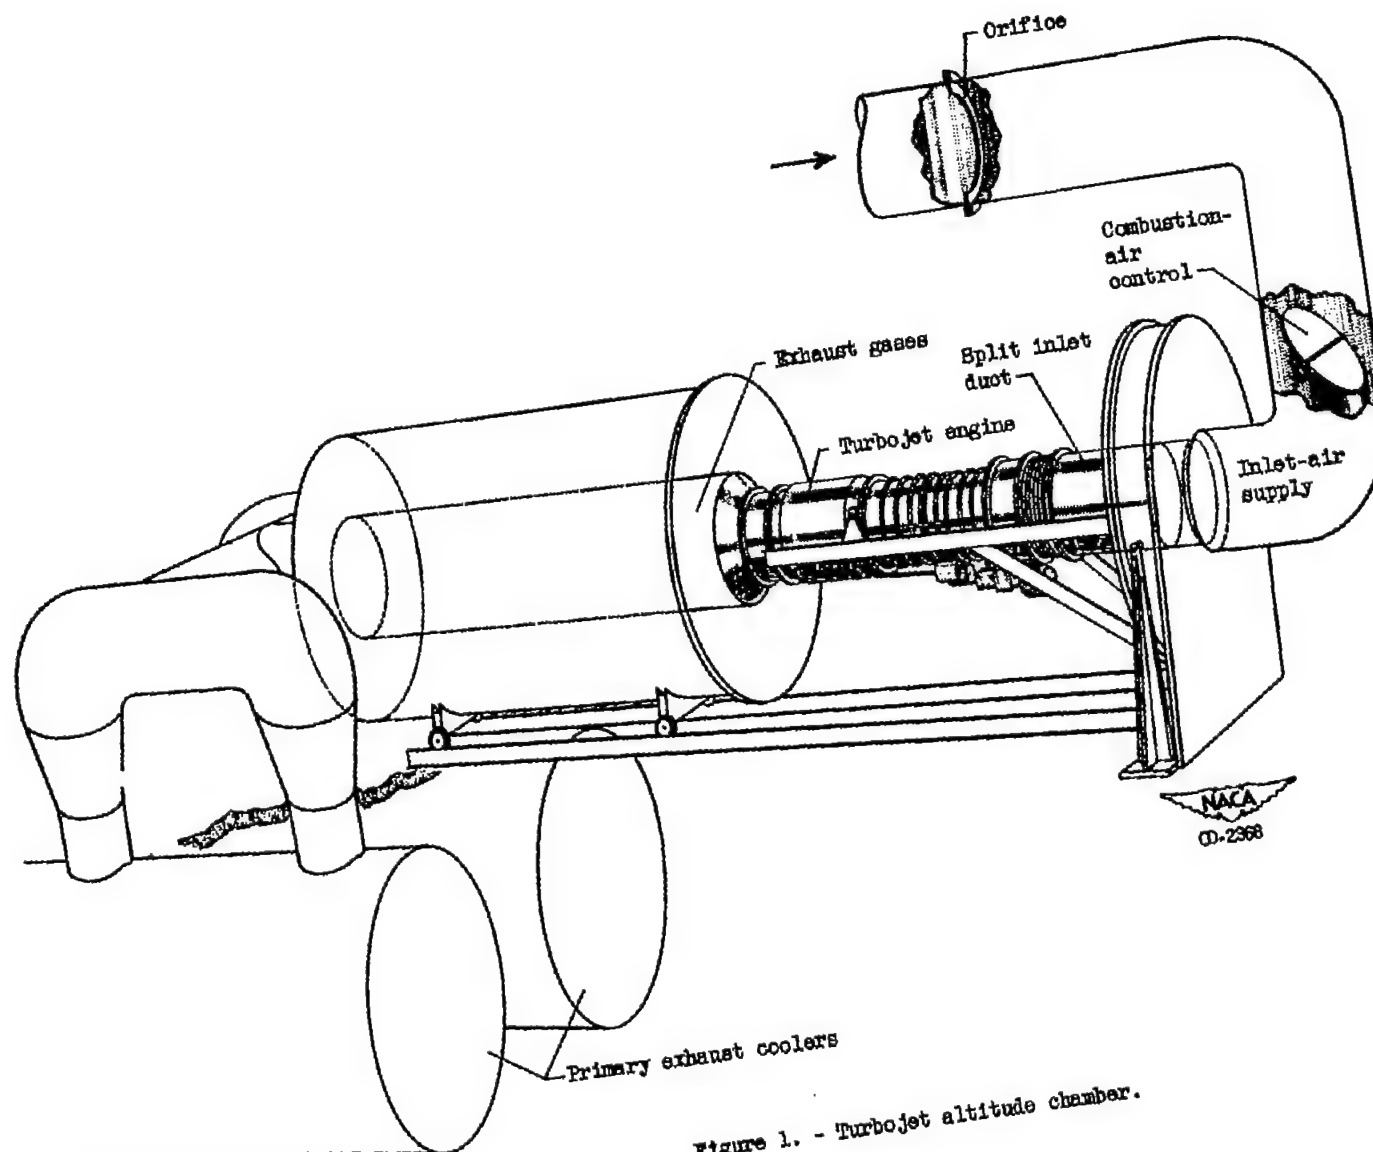
Figure 1. - Turbojet altitude chamber.

The engine was operated throughout the normal speed range of 5000 to 12,500 rpm in order to observe all blade vibrations present. The investigation was conducted with the turbojet engine operating in two different test cells. First, the engine was operated in a turbojet altitude chamber (fig. 1) where the air supply and exhaust were connected to the laboratory systems. Second, the engine was operated in a sea-level test stand where the air supply was taken from the surrounding atmosphere and exhausted through a muffler to the atmosphere. All engine parts were fabricated by the engine manufacturer and sent to the Lewis laboratory.

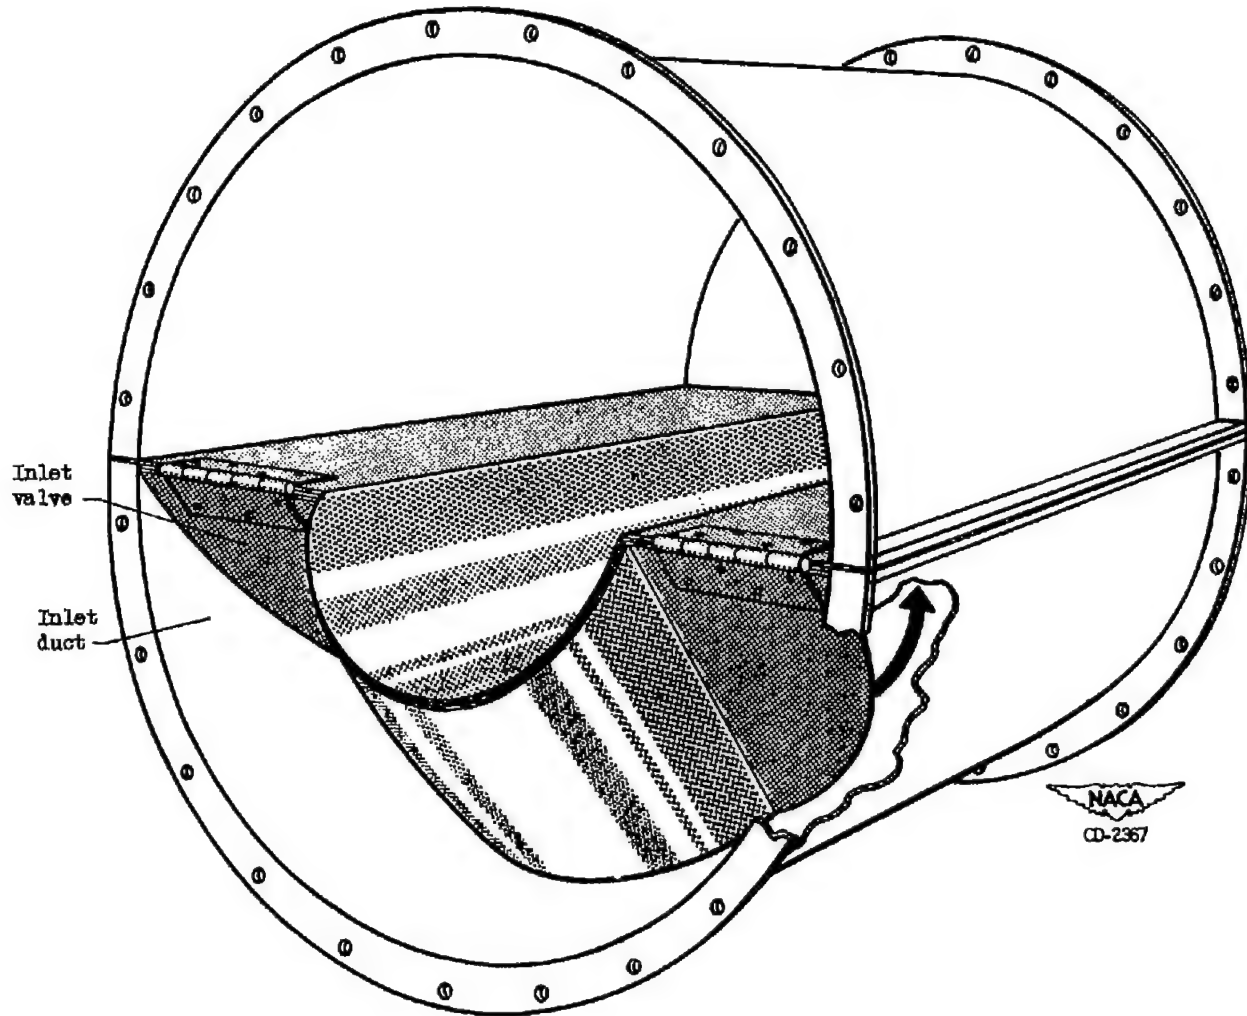
Figure 2. - Split inlet duct and inlet valve.

Inlet valve. - A special valve assembly (fig. 2) was fabricated to control the air flow to one-half of the compressor inlet from approximately zero to full flow. This valve simulated possible uneven air-flow conditions of the two-duct inlet-air supply system used in many aircraft and was used to determine the effect of flow pattern on vibration.

Inlet duct. - The section of inlet ducting containing the special valve was fabricated in two parts (fig. 2). The top half of the duct and the special valve were removed, and the engine was operated throughout the critical speed range. With the duct open the engine was receiving its air from the test cell. This procedure was carried out to determine the effect of the laboratory inlet piping on the vibration.

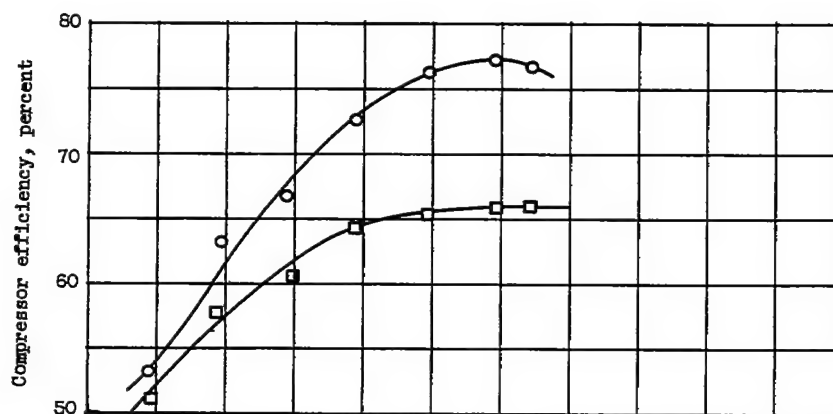
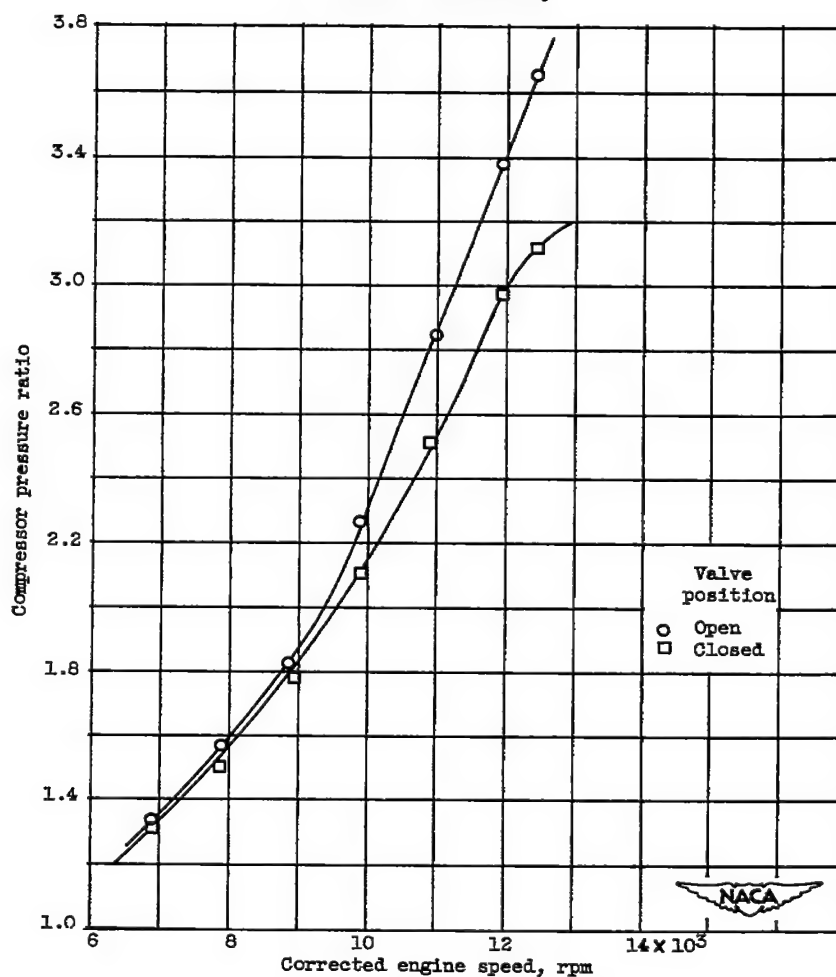
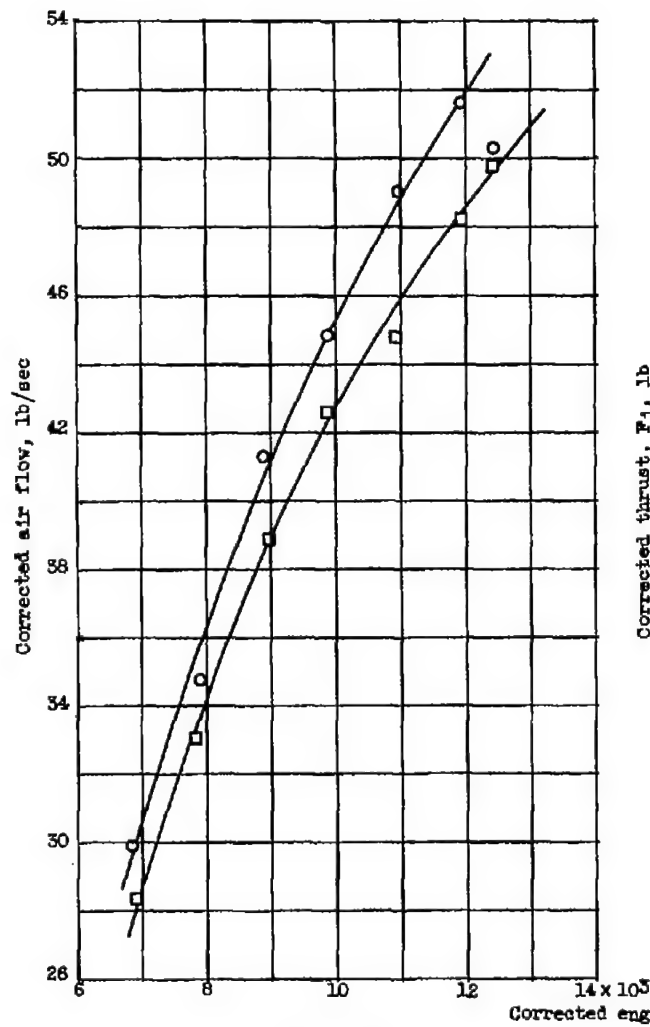
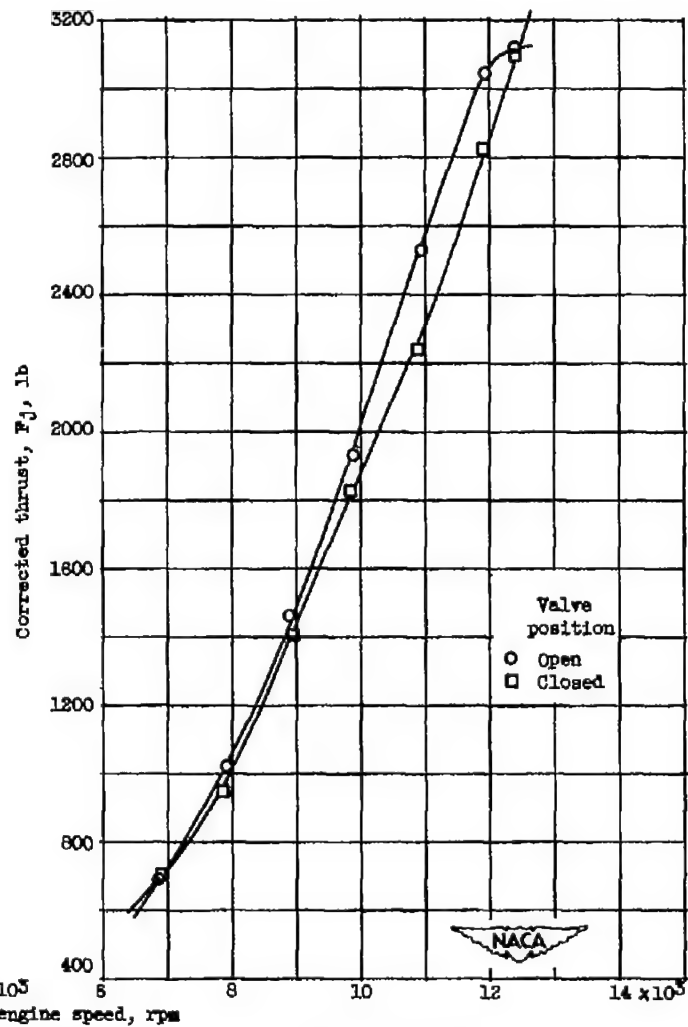
(a) Compressor efficiency.

(b) Pressure ratio.

Figure 5. - Effect of inlet-valve position on engine performance.

(c) Air flow.

(d) Engine thrust.

The valve position had a decided effect on engine performance. Figure 5 presents curves of the compressor efficiency, pressure ratio, and corrected air flow, and corrected engine thrust plotted against corrected engine speed. Operating with the closed valve reduced the corrected engine thrust approximately 9 percent. Such a loss in thrust would be serious; however, for the jet-engine installation with the twin-inlet-duct system the airplane could have one duct damaged or filled with foreign material during a flight with little or no effect on the ability of the airplane to return to its base.

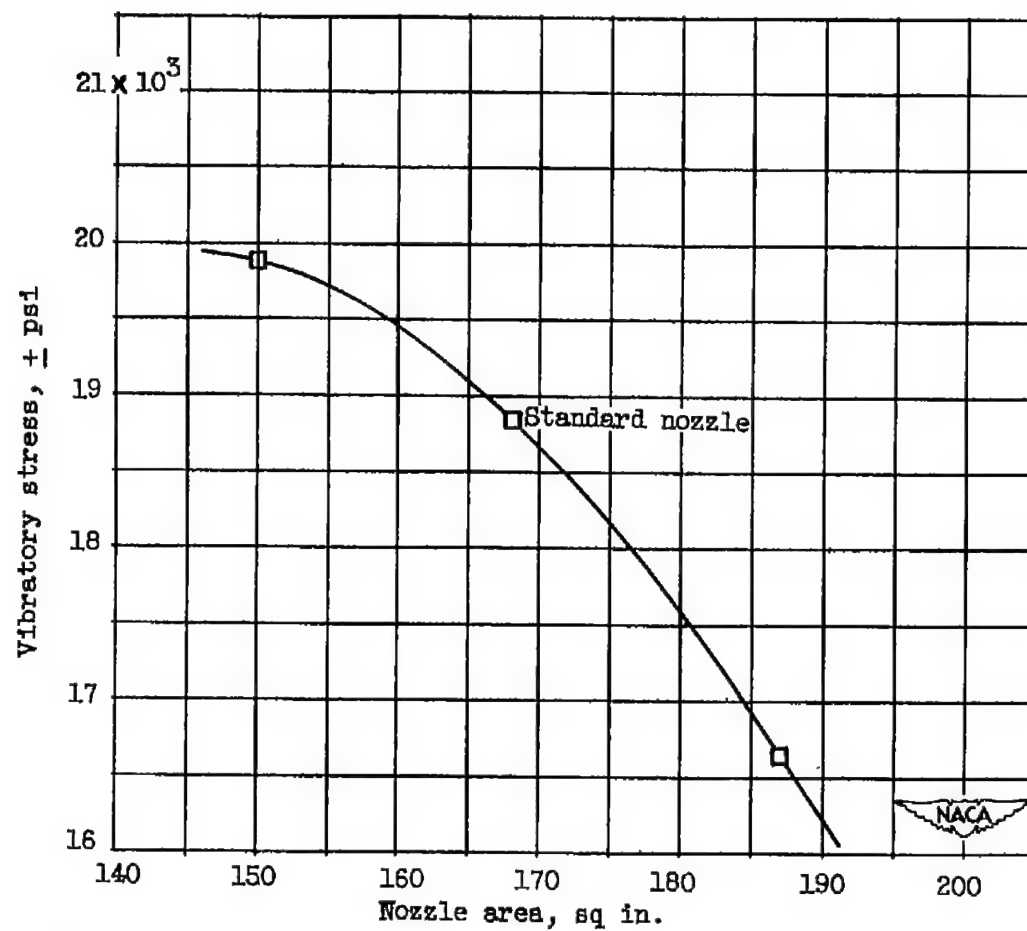
Figure 6. - Effect of exhaust-nozzle area on vibratory stress of third-stage blade.

Various exhaust nozzles. - The effect of exhaust-nozzle area on the third-stage blade vibration is presented in figure 6. As the nozzle area was reduced and the pressure ratio increased, the vibratory stress increased. This same effect was observed and reported in reference 1. The 168-square-inch nozzle was the standard for the investigation.

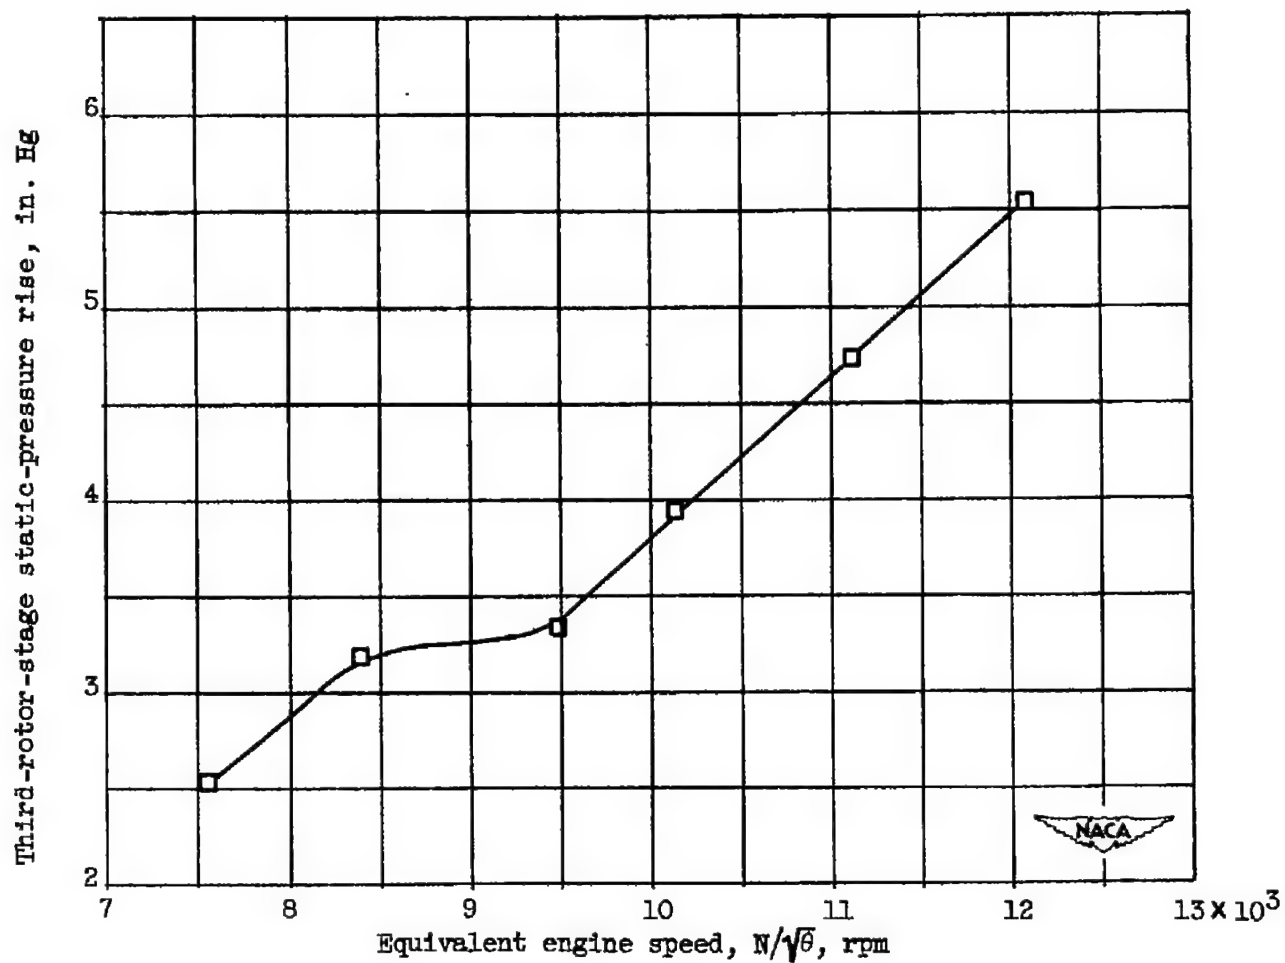
Figure 7. - Third-stage static-pressure-rise survey.

Pressure-rise test. - The third-stage static-pressure rise at equivalent engine speeds from 7500 to 12,000 rpm is shown in figure 7. A constant rate of pressure rise with engine speed was observed at all speeds except in the critical speed range from 8500 to 9500 rpm. Here the pressure remained approximately constant for about 1000 rpm, which indicated that the third stage was probably in a partially stalled condition.

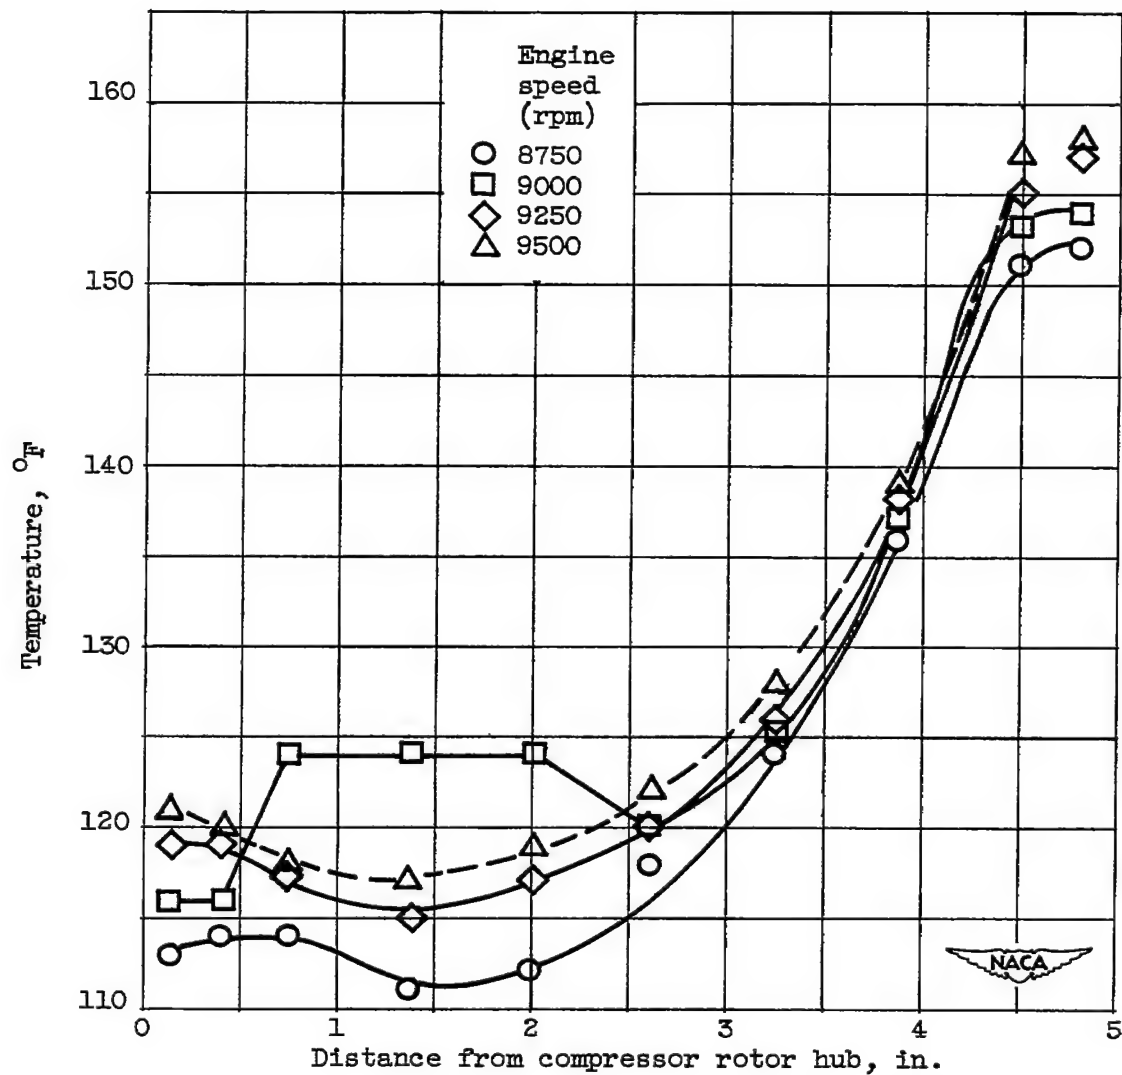
Figure 8. - Third-stage radial temperature survey.

Temperature and hot-wire measuring probes. - Data from the temperature survey of the air out of the third stage are plotted in figure 8. At all speeds the temperature increased uniformly from the base to the tip of the blade except from 1 to 2 inches from the hub at 9000 rpm. This  $10^{\circ}$  rise and the consistently high temperature at the blade tip indicate that stalling possibly exists around the lower part of the blade at 9000 rpm and at the tip throughout the complete critical speed range.

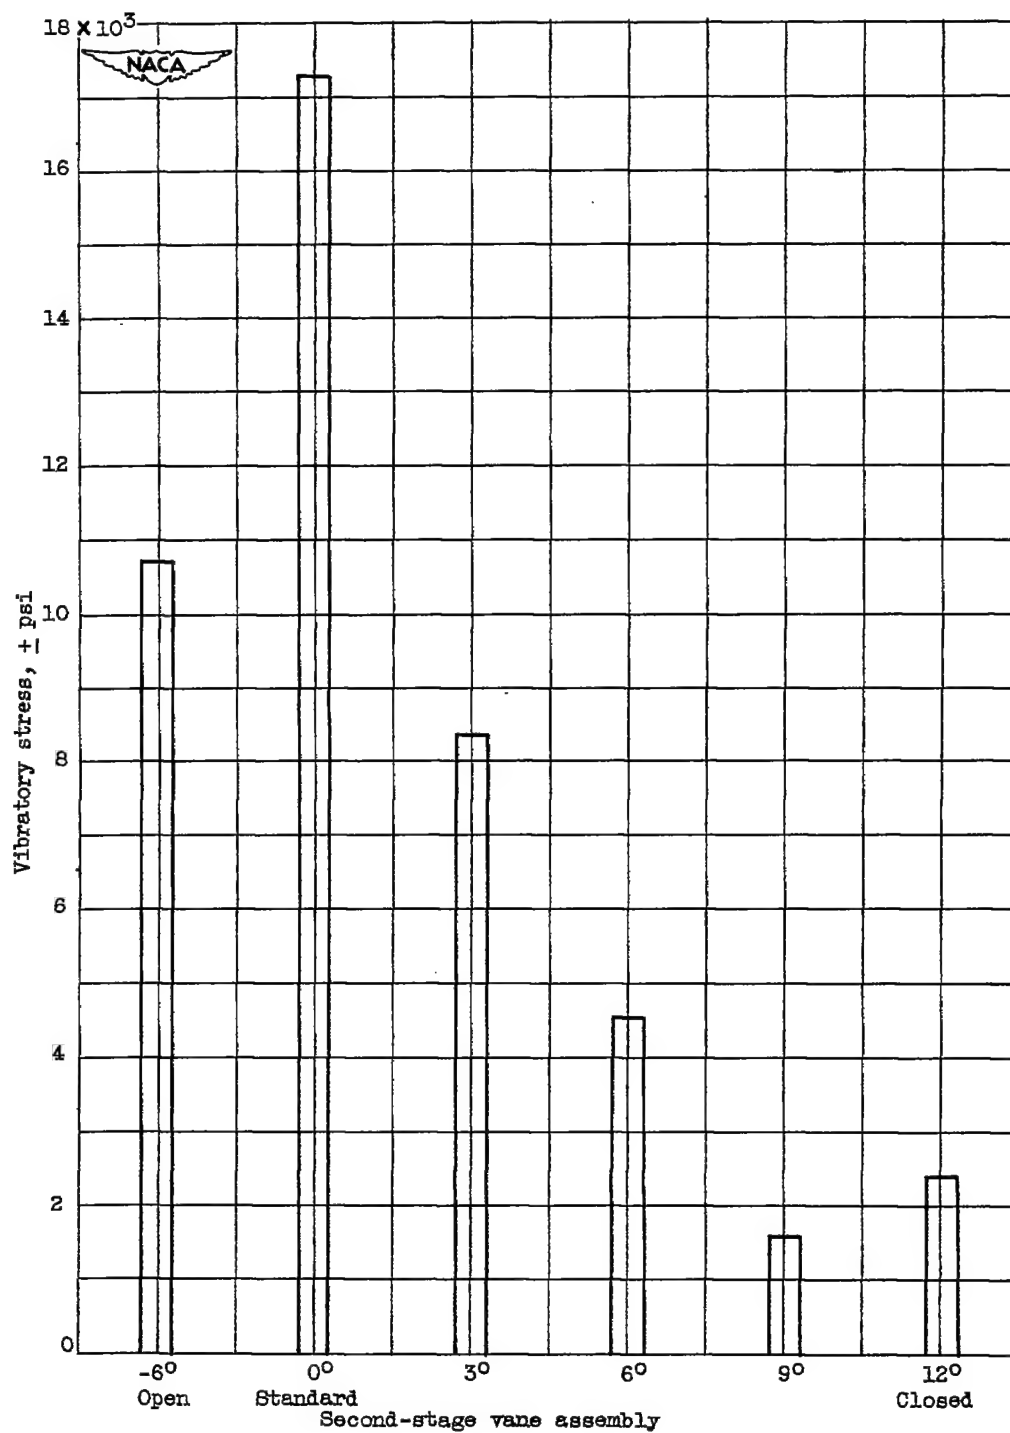
Figure 9. - Effect of second-stage vane-assembly angle of incidence on third-stage vibration.

Stator blades. - An investigation of the effect of the angle of incidence of the stator vanes immediately preceding the third stage of the compressor was conducted in a sea-level test stand; the results are shown in figure 9. The vibratory stress levels noted on this plot are averages of numerous data points of the maximum amplitude obtainable in the critical speed range for each stator angle. The number of stator assemblies tested for each angle, the resulting average stress, and the percentage of the stress produced by the standard vanes are presented in table I.

Installation of the stator with vanes closed  $3^{\circ}$  reduced the vibratory stress to less than half and would possibly bring the vibration below the danger point. A change, however, to  $9^{\circ}$  greater angle of incidence would assuredly eliminate all third-stage vibration failure of this compressor design in the critical speed range. However, with the  $9^{\circ}$ -closed

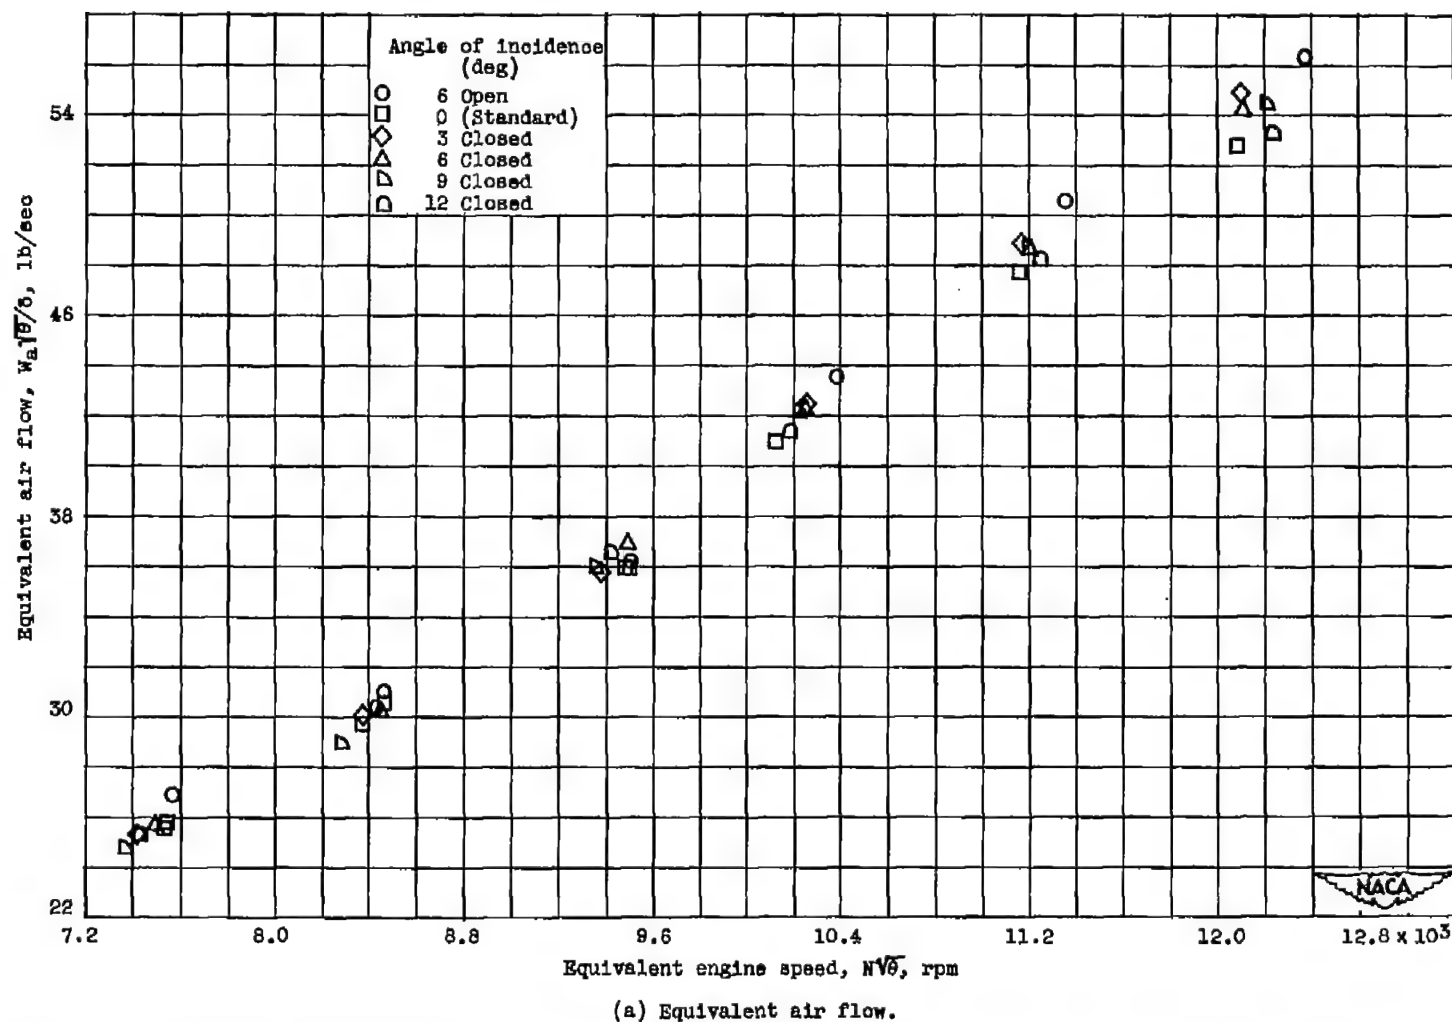
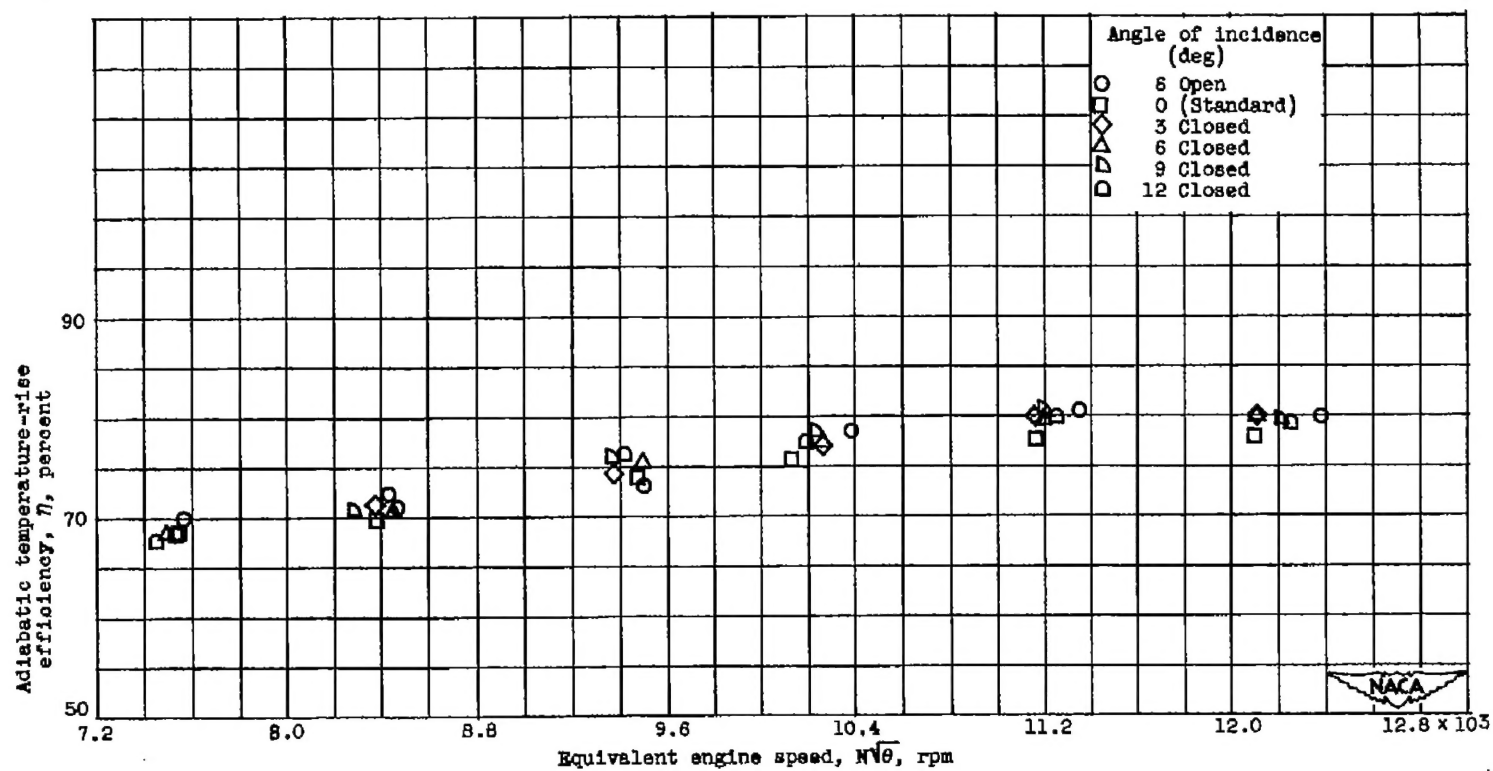
Figure 10. - Performance characteristics of eleven-stage compressor with various second-stage vane-assembly angles of incidence.

(b) Adiabatic temperature-rise efficiency.

Figure 10. - Concluded. Performance characteristics of eleven-stage compressor with various second-stage vane-assembly angles of incidence.

The complete speed range (to 12,500 rpm) was investigated with vanes of each angle to determine vibratory effects as well as engine performance. No new vibration of significant amplitude was introduced by any of the new angles. The effect on over-all engine performance is illustrated in figures 10 and 11. Although a total change of  $18^\circ$  ( $6^\circ$  open to  $12^\circ$  closed) was investigated, very little change in engine performance was detected.

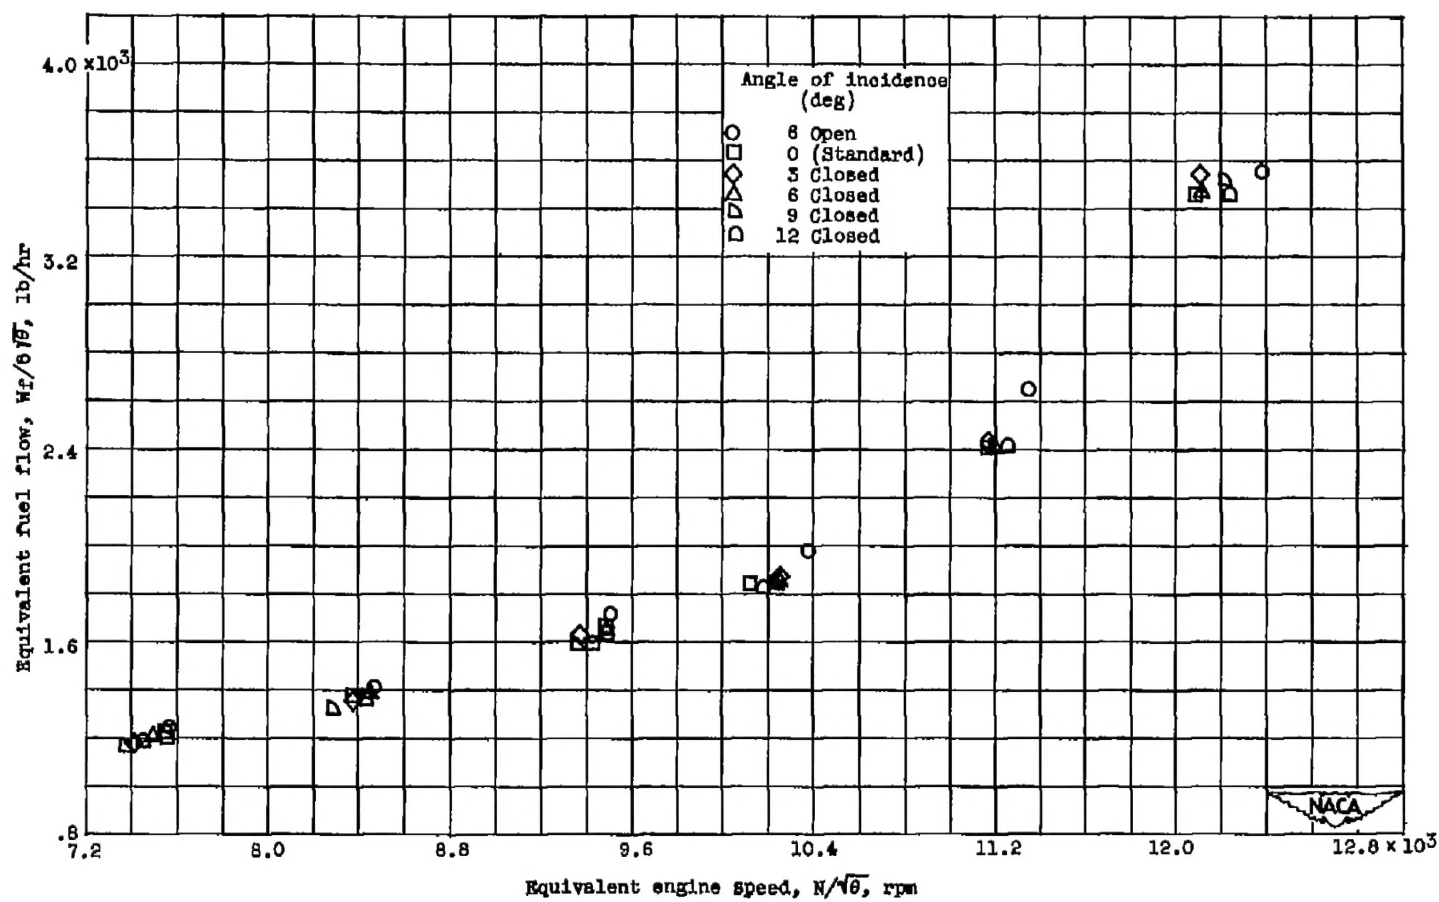
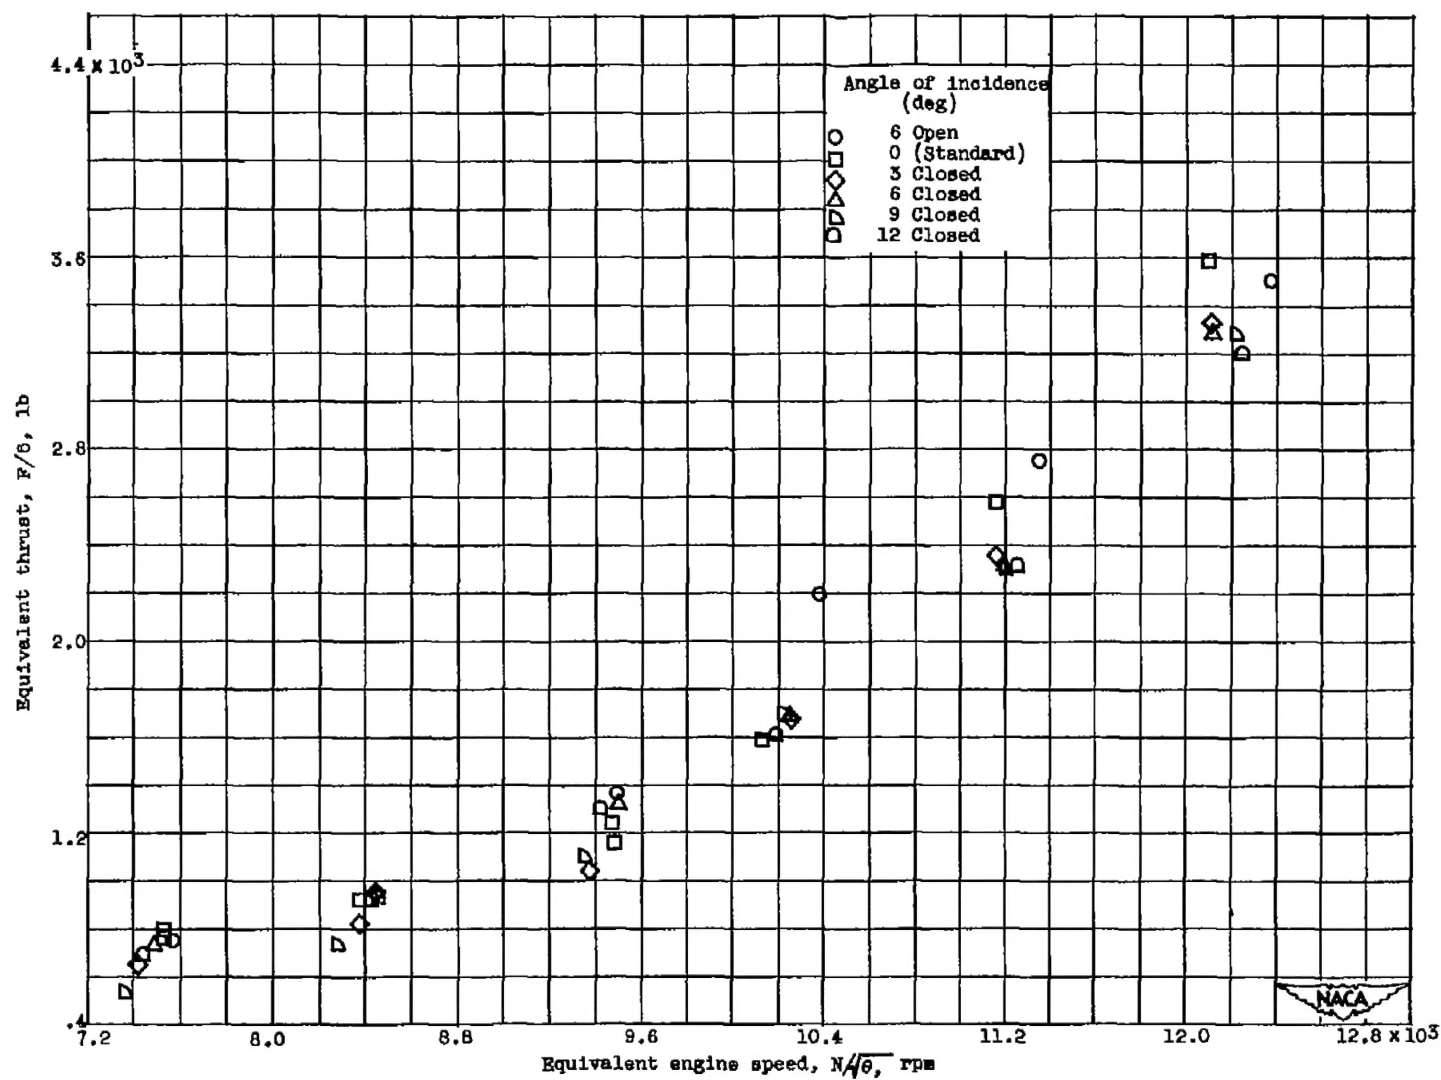
(a) Equivalent fuel flow.

Figure 11. - Performance characteristics of turbojet engine with various second-stage vane-assembly angles of incidence.

(b) Equivalent thrust.

Figure 11. - Concluded. Performance characteristics of turbojet engine with various second-stage vane-assembly angles of incidence.
